Home Inspection Report

Property Address:
111 Somewhere St
Anytown WA

45th Parallel Home Inspection

Date: 4/10/2018	Time: 01:00:00 PM	Report ID: 20180410RT-Sample
Property: 111 Somewhere St Anytown WA	Customer: Sample Customer	Real Estate Professional:

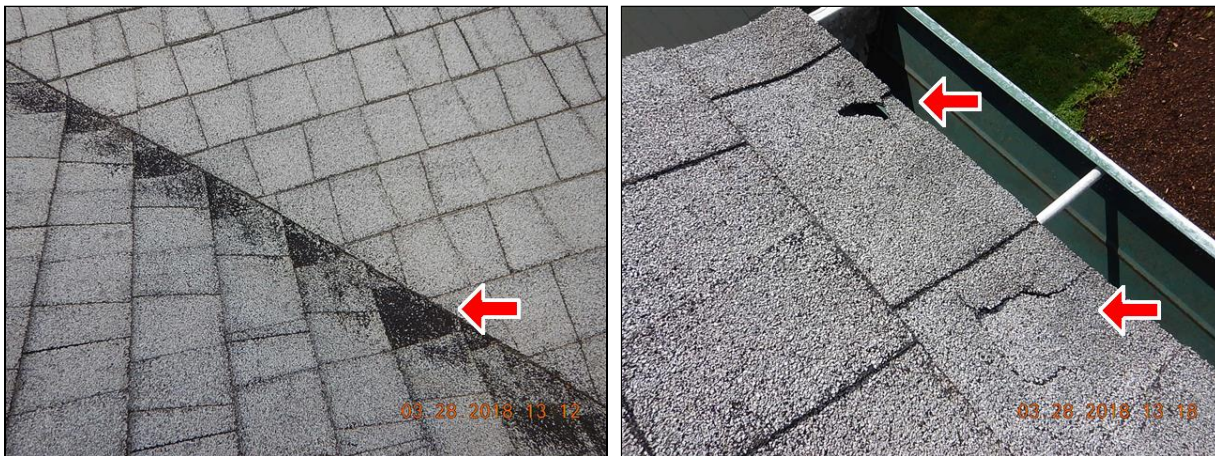
🔧 (1) There are damaged or missing shingles which need replaced as necessary by a roofer to prevent potential moisture intrusion and damage to the home's structure. Note that a representative number of areas are inspected and photos do not typically include all locations recommended for repair. Noted: damage shingles, heavy granule loss some shingles should be replaced

💰 (2) The roof appears to be at or near the end of its life expectancy. The roof should be further evaluated by a licensed roofer to determine useful life remaining and I recommend budgeting for replacing the roof covering. I estimate the roof covering will need to be replaced within the next 3 years, but repairs are necessary now.

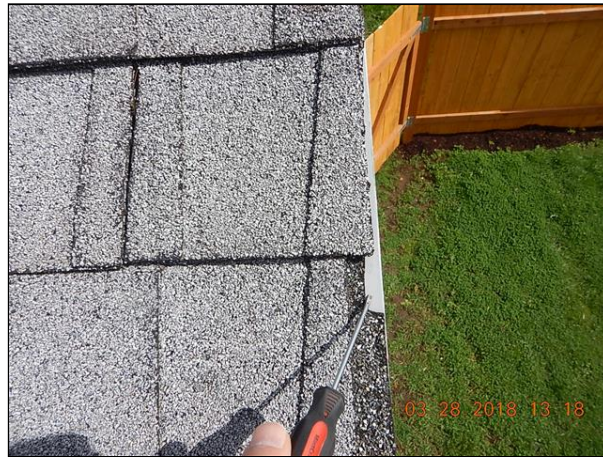
The shingles do not extend all the way to the edge of the rake flashing in one area and should be repaired for proper coverage of the flashing to prevent water penetration under the shingles and into the roof structure.

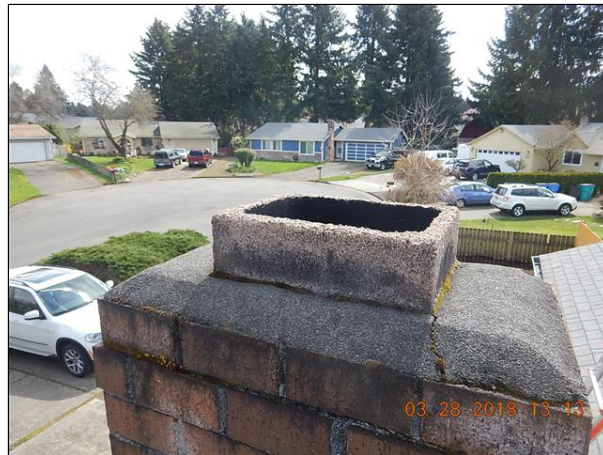
(1) I recommend a spark arrestor / rain cap be installed to keep rain from falling down the chimney flue, and to keep birds, pests etc out of the flue and help prevent burning embers from leaving the chimney area.

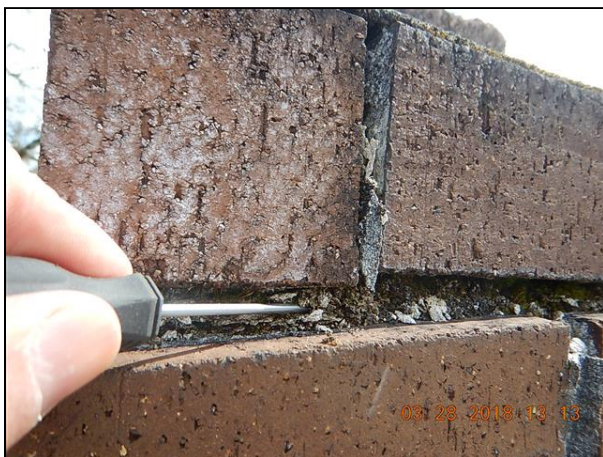
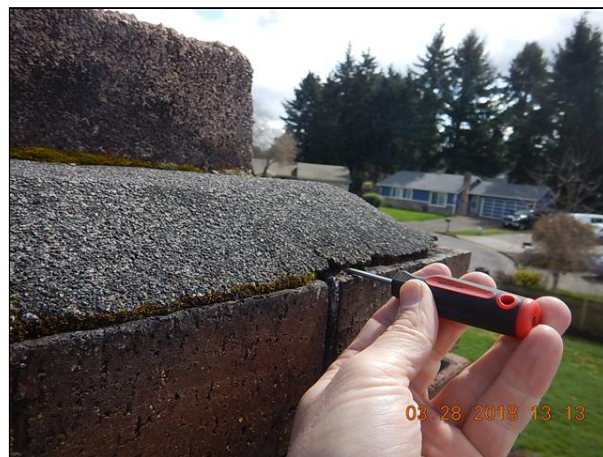
🔧 (2) There is significant deterioration of the chimney crown mortar and the brick mortar. Deteriorated chimney crown mortar may allow moisture penetration and further crack / deteriorate the crown and the mortar between bricks is crumbling and soft. I recommend repair by a mason.

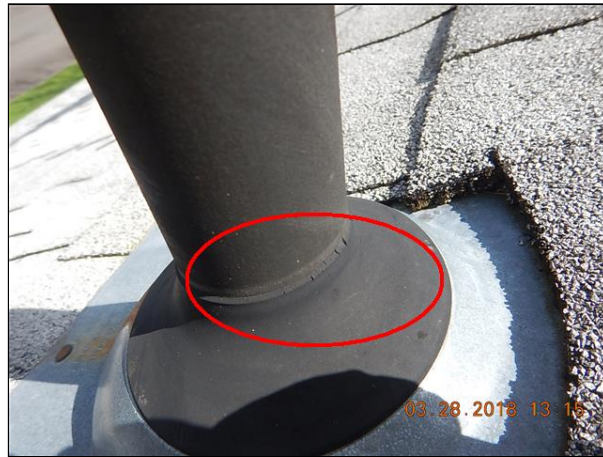
🔍 (3) The rubber boot of is a plumbing vents is cracked and / or gapping away from the vent pipe which could allow leaking either now or in the future. Monitor and replace as necessary. Noted: one plumbing boot is just starting to crack

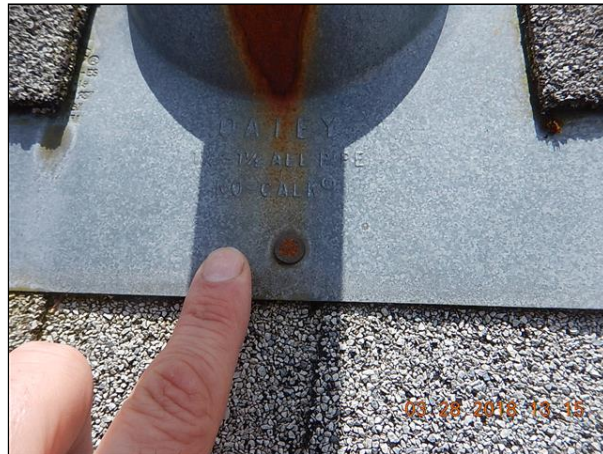
(4) Where fasteners have been driven through the roof covering leaving the fastener head exposed, it is recommended to seal the penetration with roofing cement / sealant to prevent possible leakage around that point. I recommend sealing exposed penetrations / fastener heads. Note that a representative number of areas are inspected and photos do not typically include all locations recommended for repair.

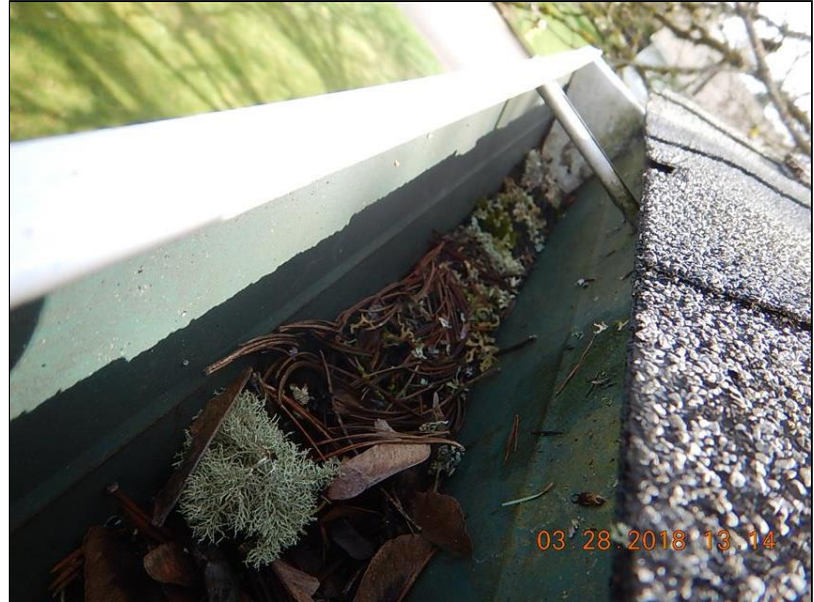
🔧 (2) The gutters contain debris in some areas and needs to be cleaned. Debris in gutters can impede proper drainage and water flow. Debris in gutters can also conceal rust, deterioration or leaks that are not visible until cleaned, and I am unable to determine if such conditions exist. I recommend cleaning the gutters.

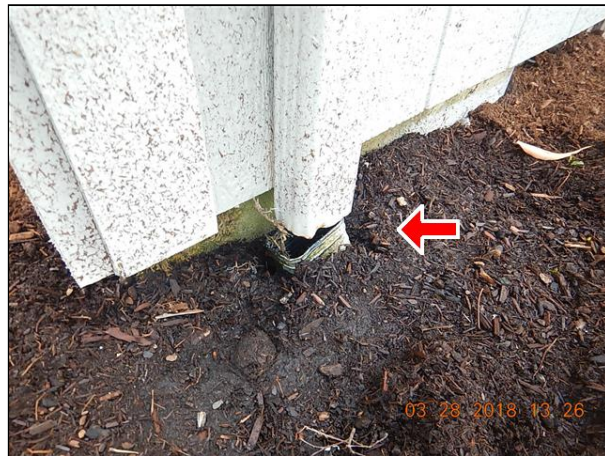
🔧 (3) The downspout is disconnected from the underground drain pipe. This can allow excess water to be deposited next to the foundation which is not recommended. Recommend repair. Areas noted: SW corner

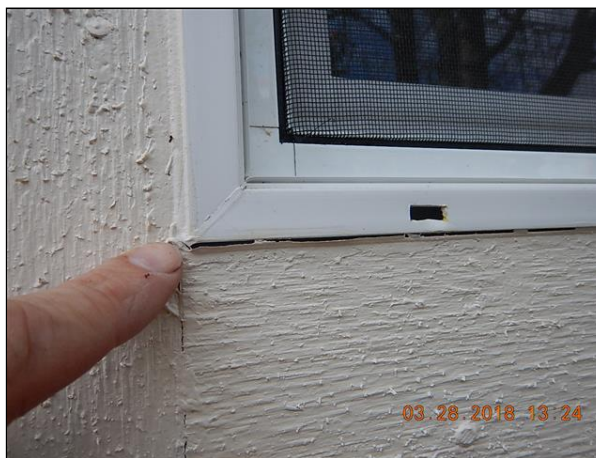
(1) The caulking is cracking or gapping at siding / trim, windows or siding butt joints. This is a maintenance item and should be periodically inspected and repaired as necessary. I recommend re-caulking in these areas to prevent moisture intrusion and potential damage to the structure. Noted: 1 window front of home

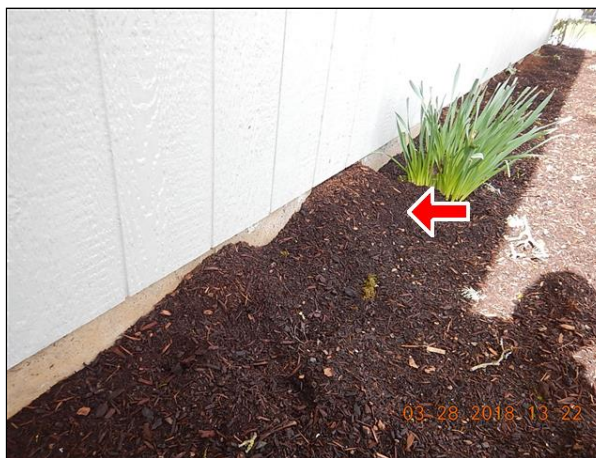
🔨 (2) In general, it is recommended to have 6 inches of clearance from bottom of siding over ground cover, and 2 inches over hard surfaces such as driveways / walkways. This is to prevent potential moisture damage to the structure and to help prevent pest intrusion. There is less than recommended clearance in some locations, and I recommend correction. Areas noted: multiple areas around the home

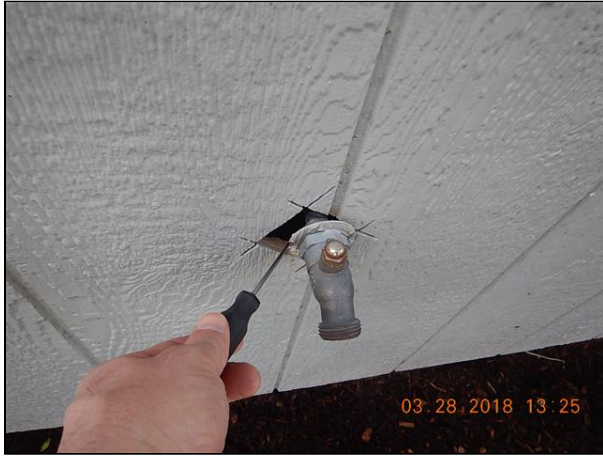
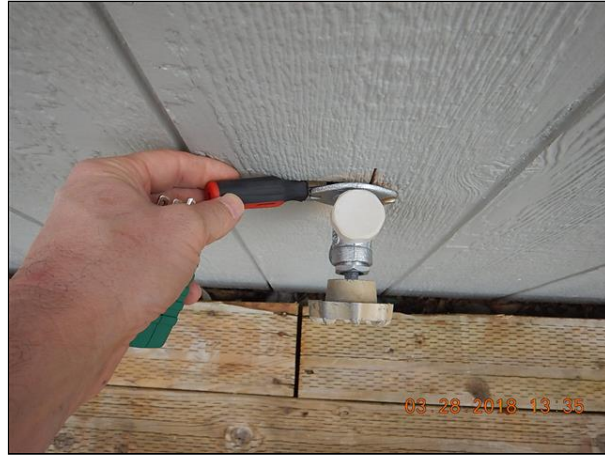
🔧 (4) There is an open penetration into the wall in some areas that need to be properly blocked and sealed to prevent moisture damage to the structure. Noted: front and rear of home at hose bibs

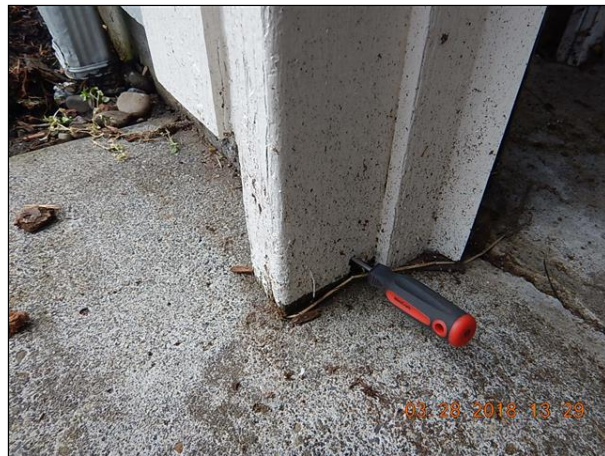
🔧 (5) There is some trim / siding around the home that has some wood rot / deterioration. I recommend repair. Areas noted: garage door jamb

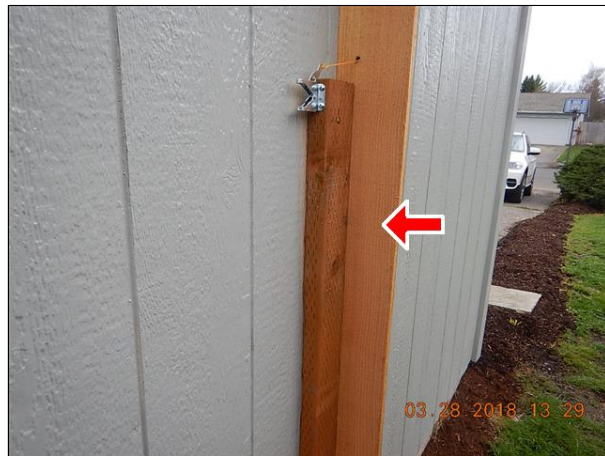
🔧 (6) I recommend not fastening fencing to the home's siding. This can trap water behind the board(s) and damage the siding / structure. I recommend a fence post at least 1 inch away from siding.

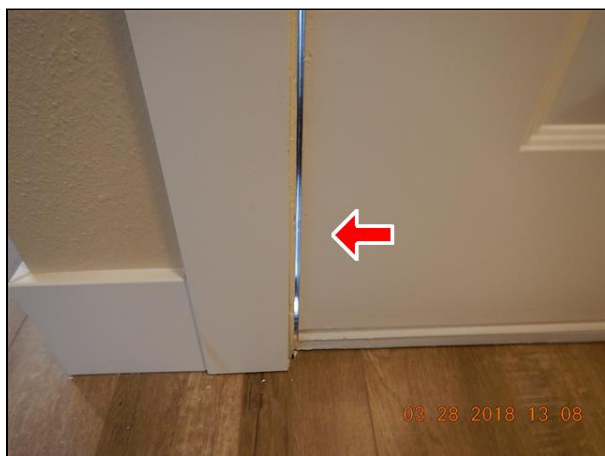
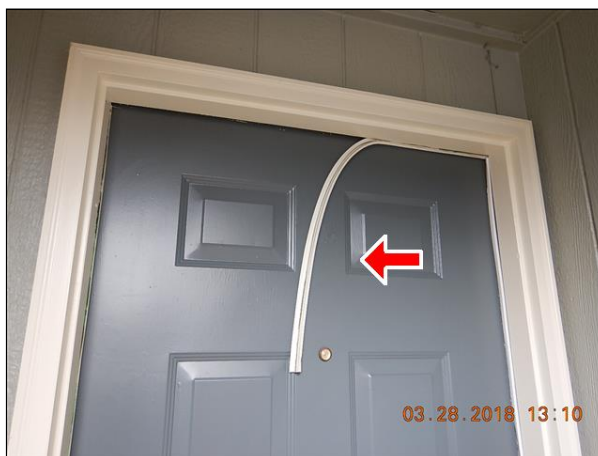
- (1) I recommend changing / re-keying all locks and garage door codes upon moving into the home.
- (2) The weather strip around the door is damaged, deteriorated, missing or gapped. Recommend repair / install weather stripping in this area to seal any gaps around the door. Areas noted: Front door bottom corner and top

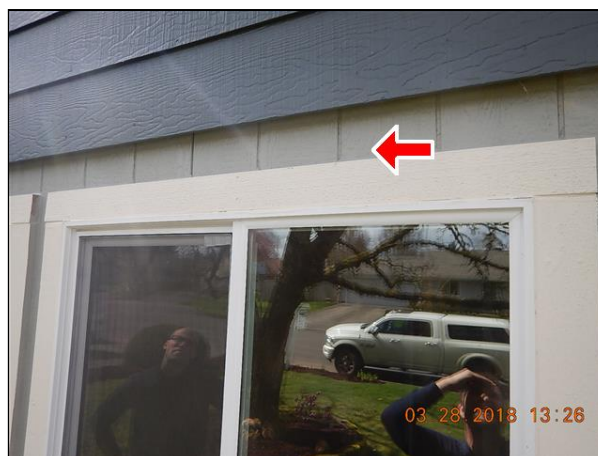
As a note, there is no head flashing installed over windows. Head flashing helps prevent water penetration around the top of windows, doors, light fixtures. It is important to keep windows without head flashing properly caulked and maintained to prevent moisture intrusion. Recommend periodic review of areas over windows and doors, fixtures etc and keeping them in well maintained condition with no gaps for water entry.

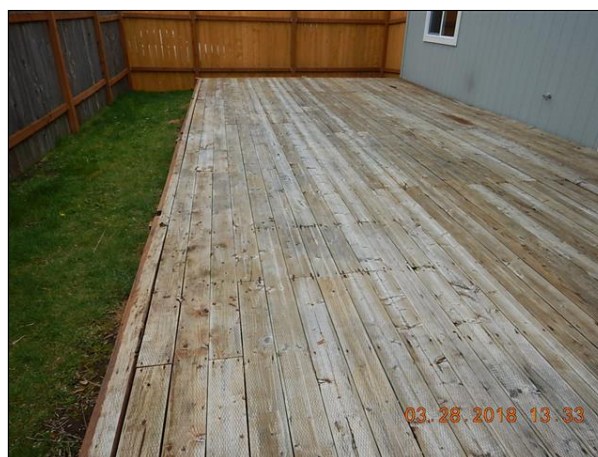
- (1) I recommend painting / staining the deck to extend the life of the wood.

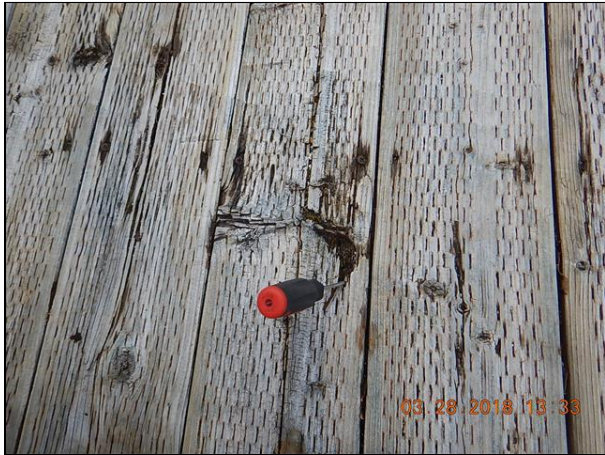
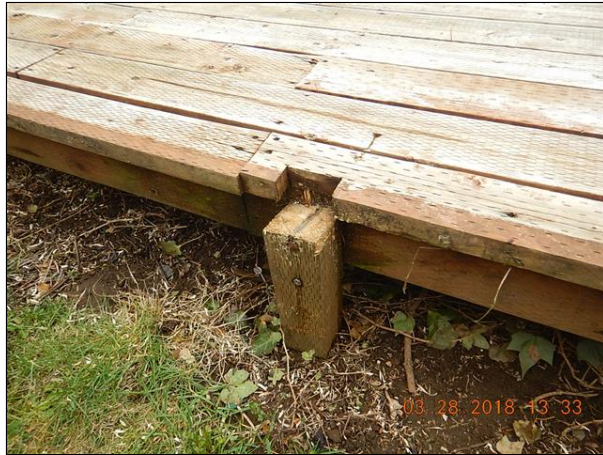
(2) The deck structure has been modified. The old railing has been cut off. The rim board / outside beam area is not supported but is bolted to the columns. Deck structure is in contact with the soil. Minor wood rot noted in deck. One loose board at rear of deck needs replaced. There are some things that will require repair going forward, but it is functional at present. Monitor and repair as necessary.

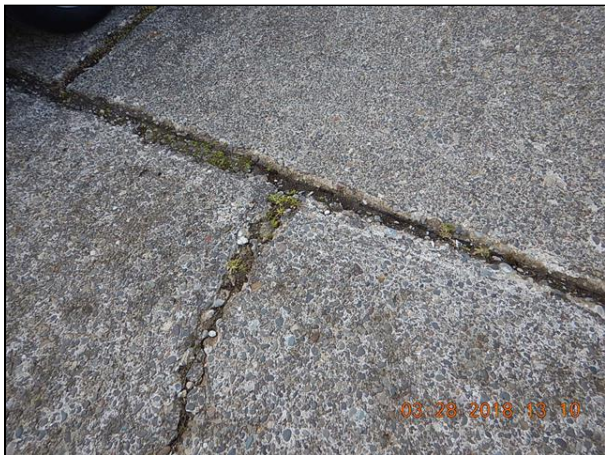
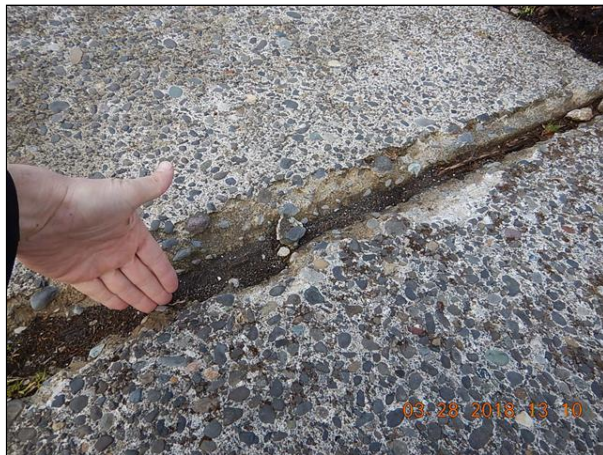
(1) There is significant cracking of the concrete in one or more areas of walkway / driveway. I recommend repair as necessary. The driveway is still serviceable as-is. Noted: driveway large cracks can be repaired as necessary

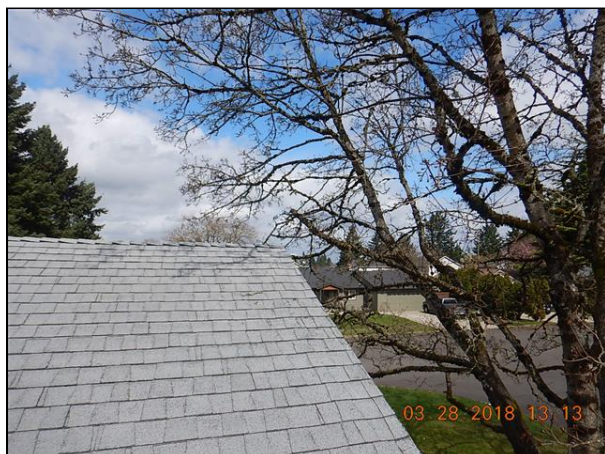
🦅 (2) Tree limbs that are in contact with roof or near roof should be trimmed to avoid potential damage to home and roof covering and to prevent potential pest intrusion. I recommend trimming vegetation / branches away from roof by five feet.

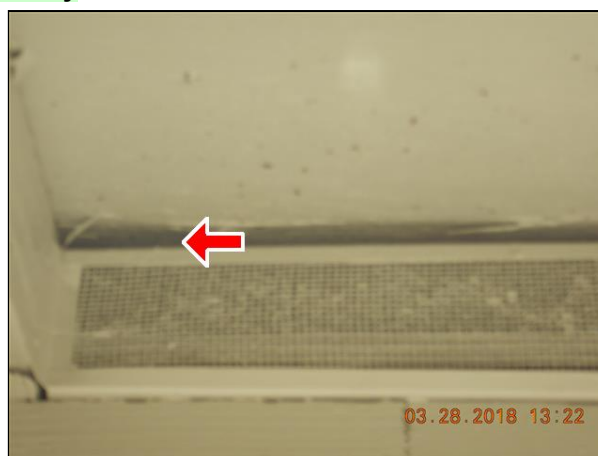
There are some gaps in the eaves which lead to the attic. I recommend sealing any sizeable gaps to prevent potential pest intrusion. Areas noted:

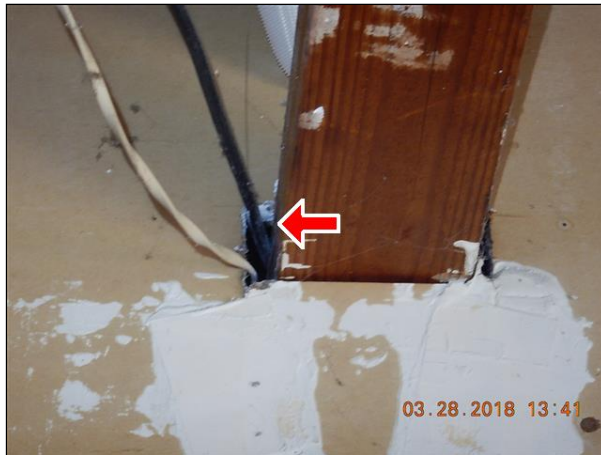
+ There is a hole / gap in the shared house / garage wall. In current construction, the drywall on the common walls and ceiling from the garage to the home serve as a fire barrier separation and should not contain any holes or gaps. Any holes in the fire separation wall / ceiling allows direct access to the house structure should a fire start in the garage. This is a potential safety hazard. I recommend patching / repairing any holes or gaps and taping and mudding any seams. Small holes can be filled with fire rated foam. Noted: small gaps / holes in fire wall of garage

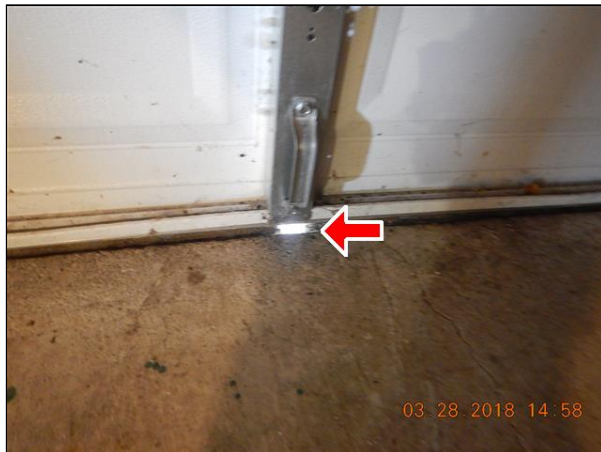
Some weather stripping is missing around the garage door edges / bottom. I recommend repair to prevent pest intrusion.

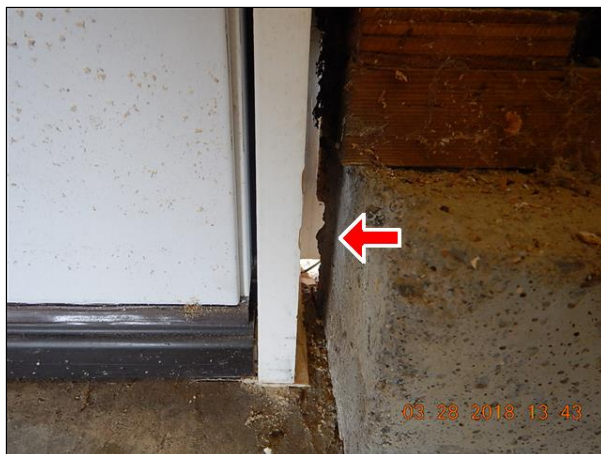
There is a gap around the bottom of the service door which should be filled to prevent pest intrusion.

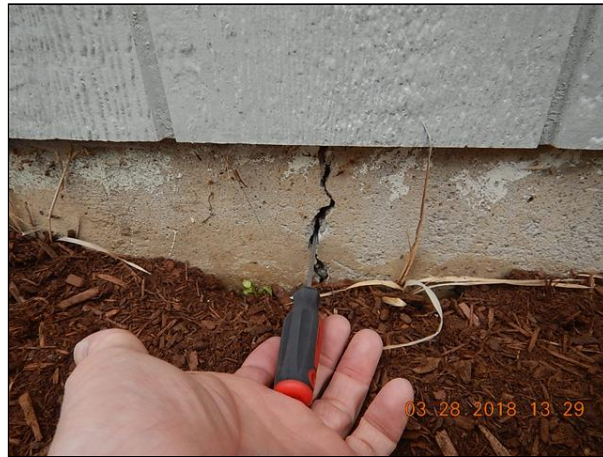
(1) There is a larger than typical crack (about 1/16th inch) in the foundation on the North side / garage side of the home. A crack this size is not structurally concerning, but I recommend monitor it for any changes and consult with a contractor if changes are noticed. Ensure downspouts move water away from the home in all areas.

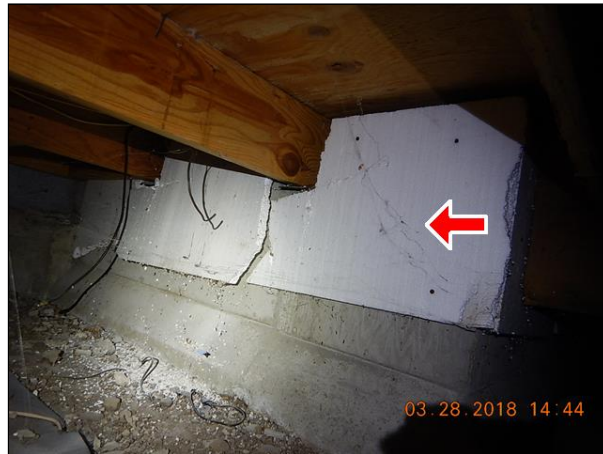
(2) There is insulation / foam installed on the interior foundation walls and the foundation is mostly not visible for inspection.

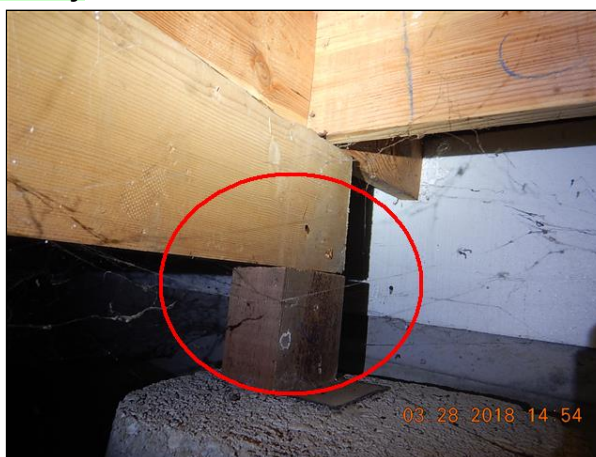
✘ (1) The support posts lack post to beam gussets in the crawlspace and positive attachment from posts to footings. Gussets or metal plates at the post to beam connection help provide structural stability during a possible seismic event. Gussets and footing anchoring are not typically found in older structures and should be considered as a future optional upgrade for seismic preparedness.

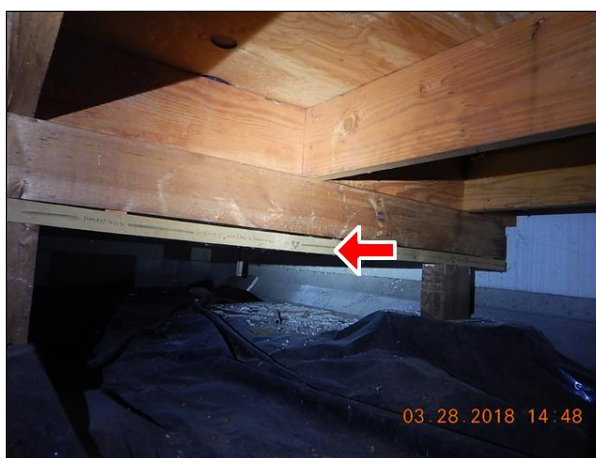
(2) There is a non-typical beam configuration in one area where the beam has been shimmed with a 2x4. I see no issue as a result, and it seems to be performing OK as-is.

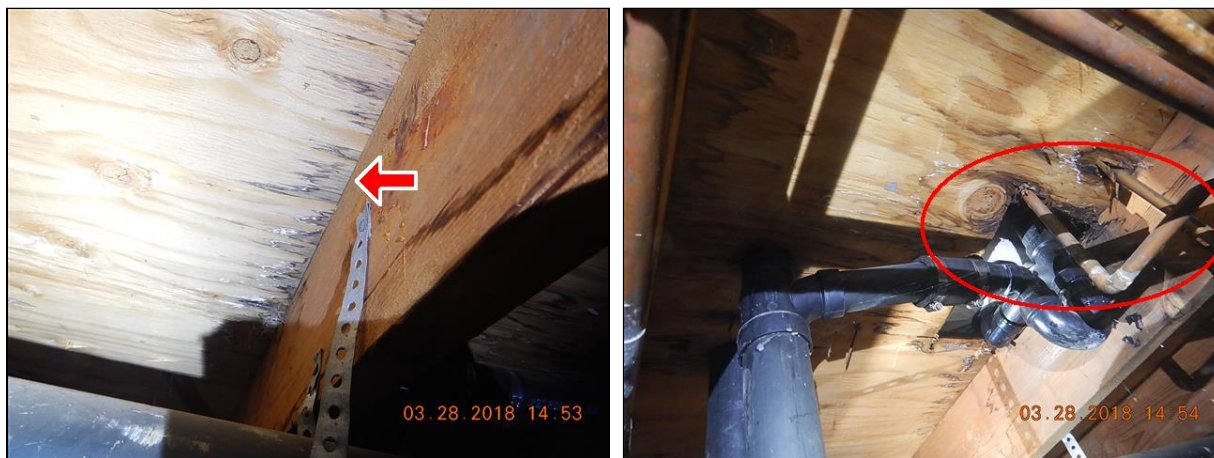
There is moisture staining of the floor in some areas. There does not appear to be any current active leaking.

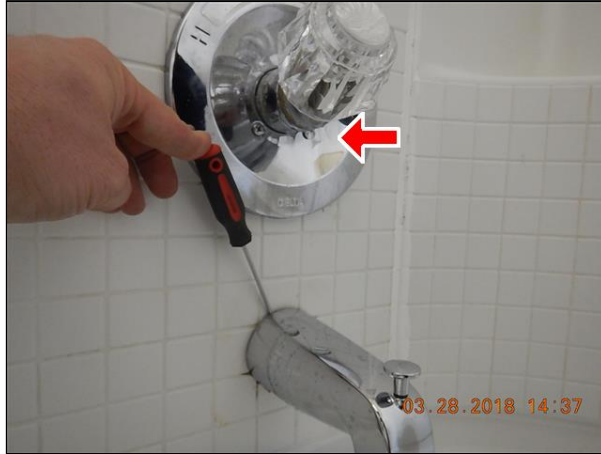
🔧 (6) There is a leak at one or more plumbing fixtures. I recommend repair. Areas noted: hall shower / tub faucet leaks.

Caulk the area around the spout as water can run behind it and into wall.

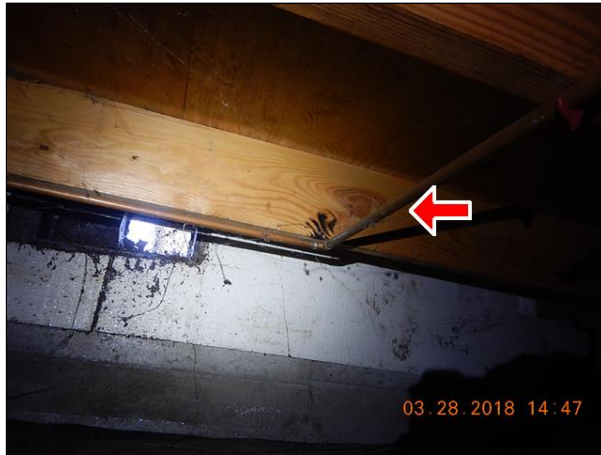
🔧 (8) Some areas of the water distribution piping in an unconditioned area not insulated. It is recommended to insulate water distribution piping in unconditioned crawlspaces, basements, and attics. I recommend insulating the water distribution piping in exposed areas. Noted: crawlspace

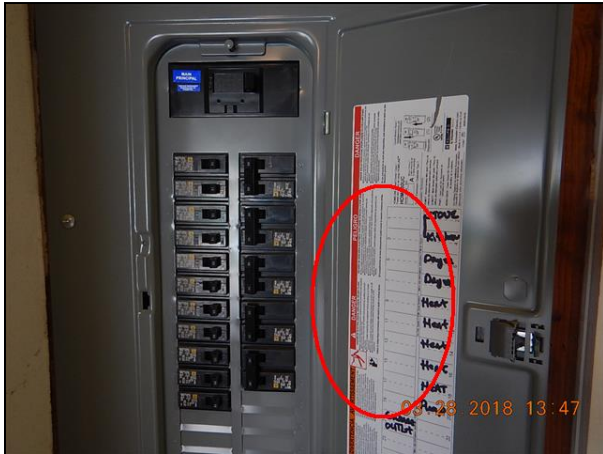
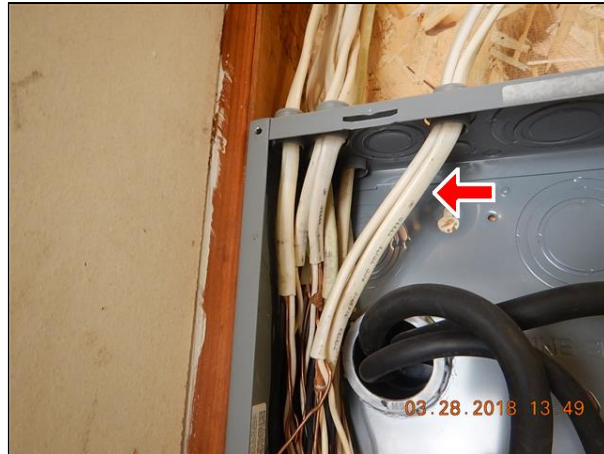
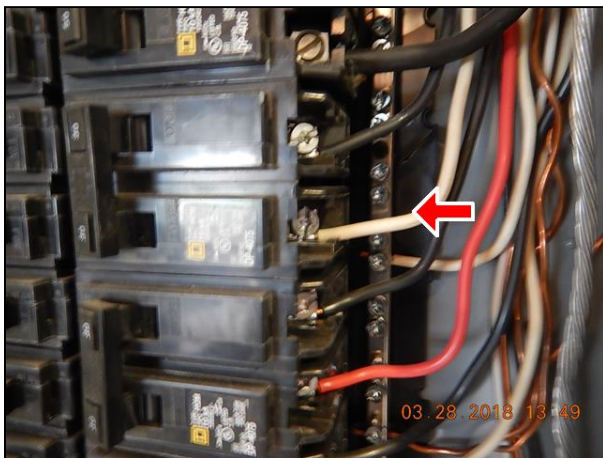
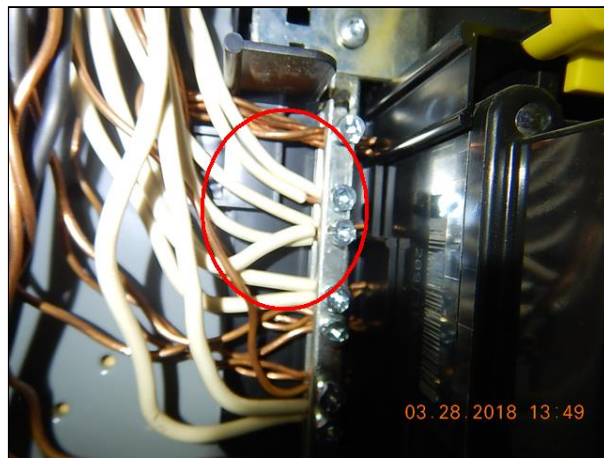
⚠ (2) There are multiple defects noted in the main electrical panel or auxiliary panel. Issues noted, but are not limited to: breakers are not clearly labeled for quick location in an emergency (safety item), white neutral wires used as hot and not relabeled multiple neutral wires under one terminal, wire jackets not stripped back to within 1 inch after entering panel. I recommend review and repair as necessary by a licensed electrician.

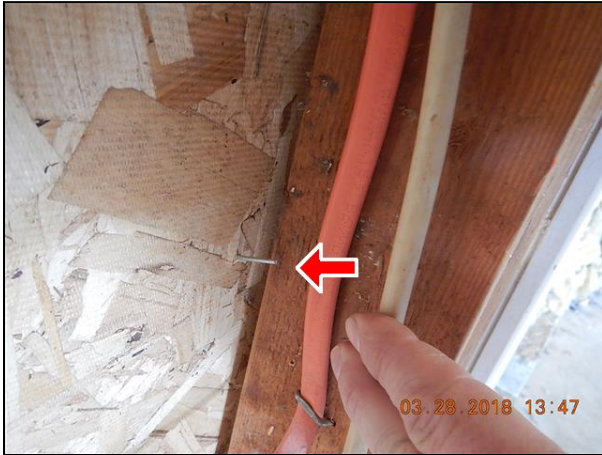
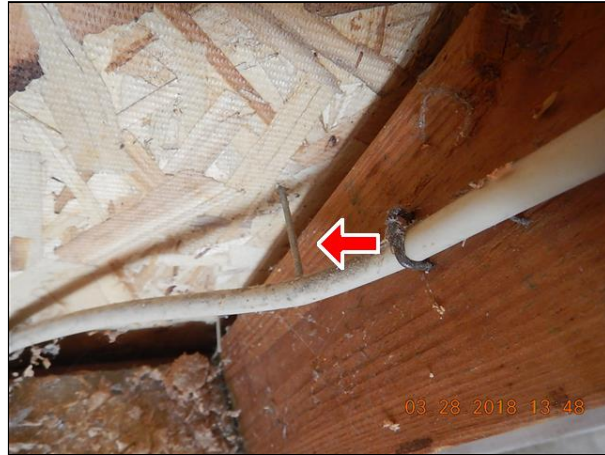
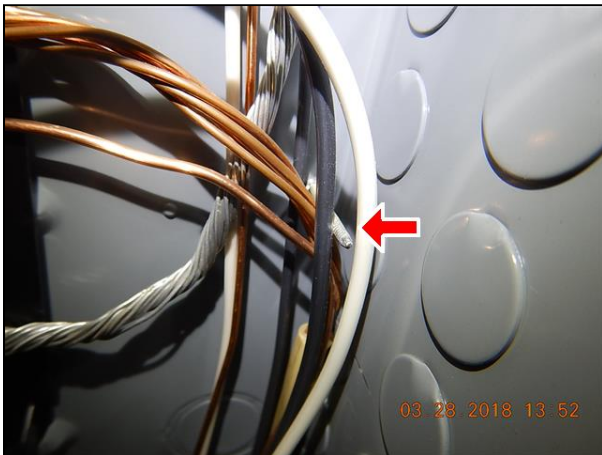
(3) There are multiple penetrations of nails / screws into the panelboard and panelboard area near wires. These should be removed as they could become live if they pierce wires. I recommend repair by an electrician.

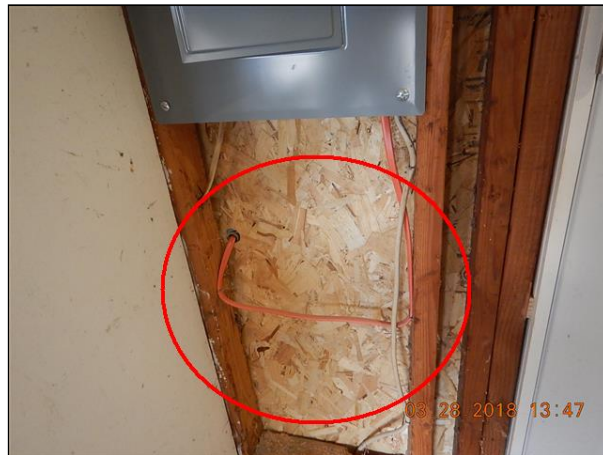
(4) I recommend covering the exposed wires at the bottom of the panel board to prevent accidental damage / contact.

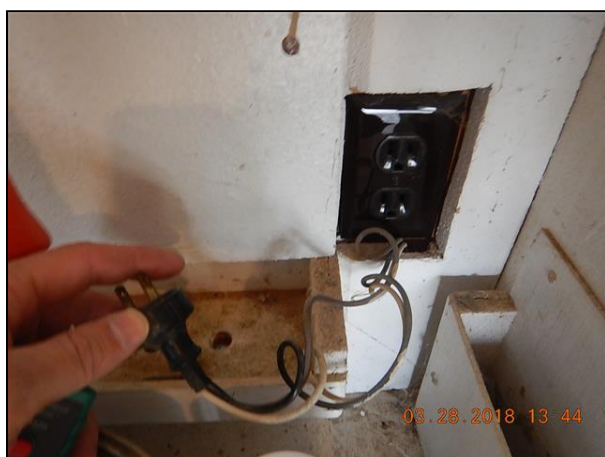
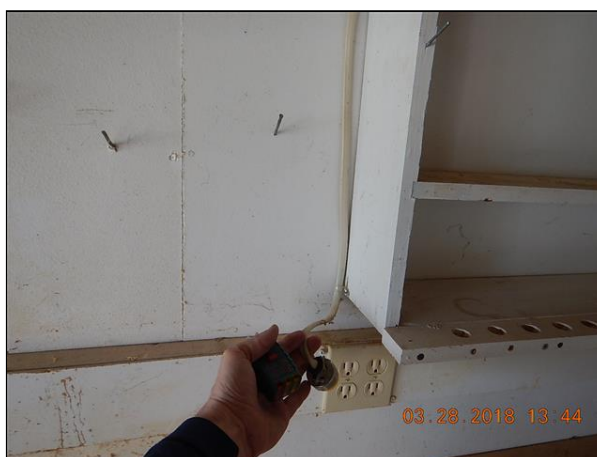
⚠ (4) There is non-professional type of wiring in some areas of the garage that I recommend an electrician review and correct for safety. The wiring is not properly installed / protected.

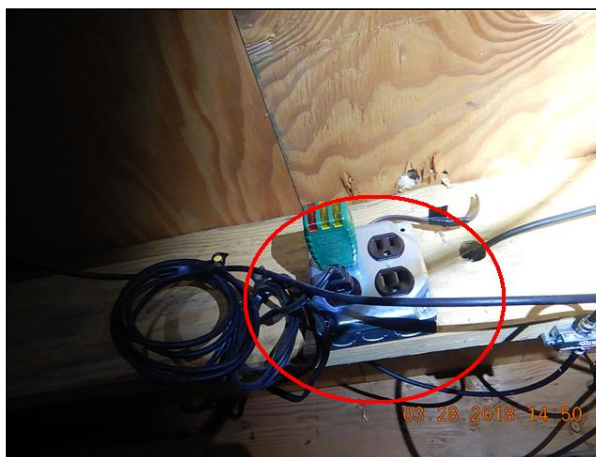
👉 (5) There is some electrical cabling in the crawlspace / attic which appears to be abandoned. There was no voltage at the cabling / outlets. I do not know if there is potential for this to be energized. I recommend having it removed as there is no real necessity for it. Note: any outlets in crawlspaces should be GFI protected

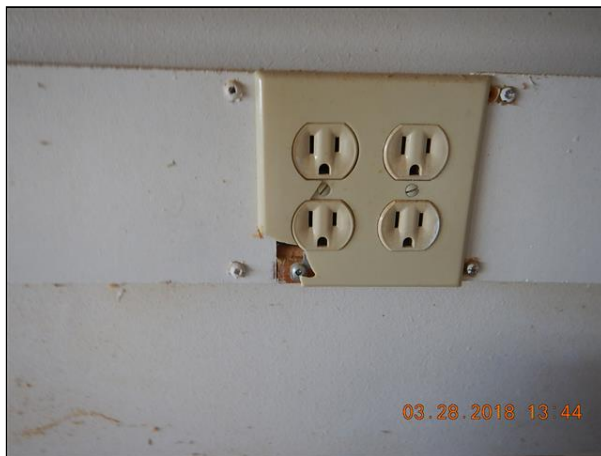
(3) There are one or more broken electrical receptacle or light switch cover plates. I recommend repair. Areas noted: garage

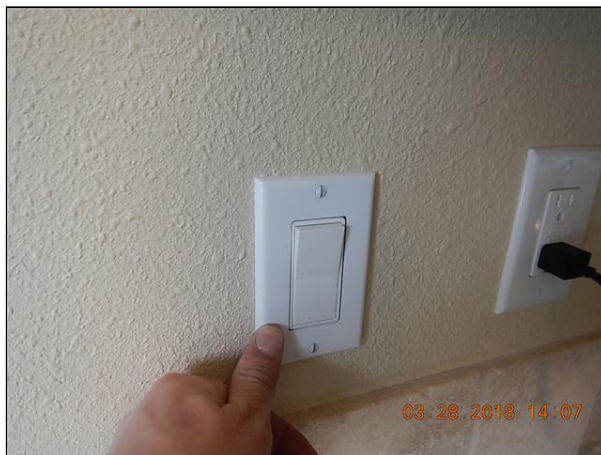
(4) The food waste disposal rocker switch is upside down, have it fixed if it bothers you to be backwards.

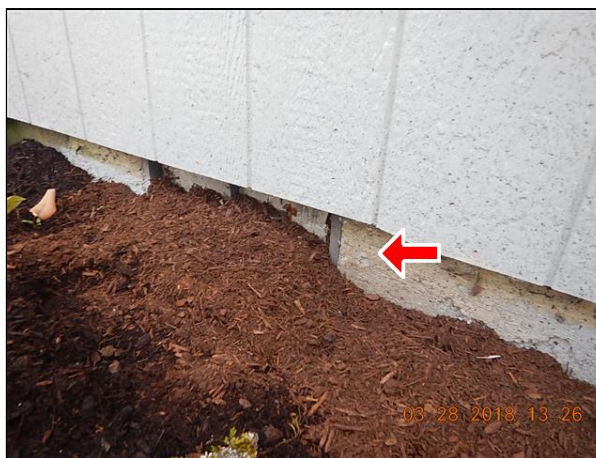
(2) The crawlspace vents are at or below the ground level in some locations. Recommend repair of landscaping to always keep crawlspace vents above grade to prevent moisture intrusion.

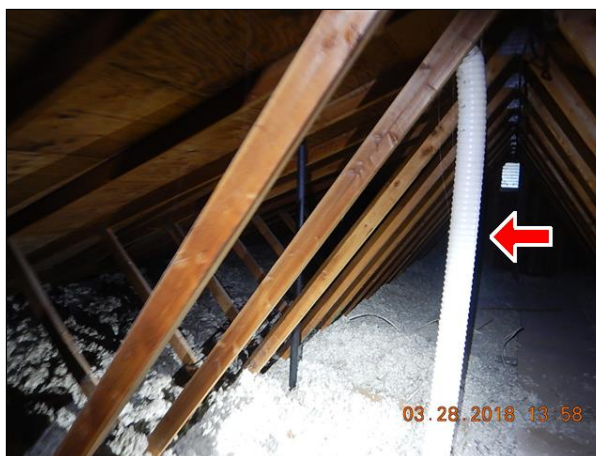
(3) The bathroom exhaust duct is made of flexible vinyl or foil. I recommend replacement by an insulated smooth walled metal or semi-rigid metal exhaust pipe to prevent potential condensation and damage to the ceiling.
