Home Inspection Report

Property Address:
111 Somewhere St
Anytown WA

45th Parallel Home Inspection

Date: 4/10/2018	Time: 01:00:00 PM	Report ID: 20180410RT-Sample
Property: 111 Somewhere St Anytown WA	Customer: Sample Customer	Real Estate Professional:

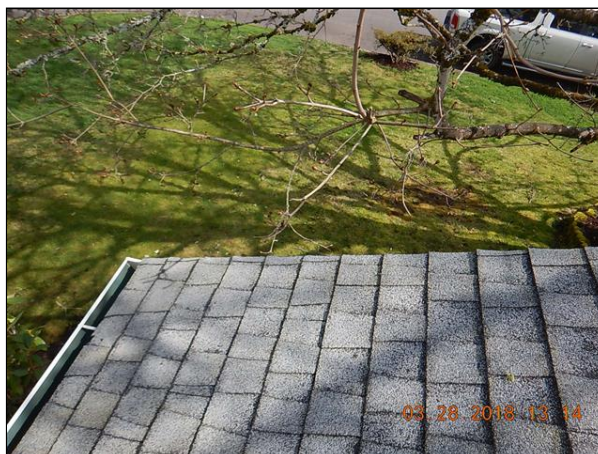
🦅 (2) Tree limbs that are in contact with roof or near roof should be trimmed to avoid potential damage to home and roof covering and to prevent potential pest intrusion. I recommend trimming vegetation / branches away from roof by five feet.

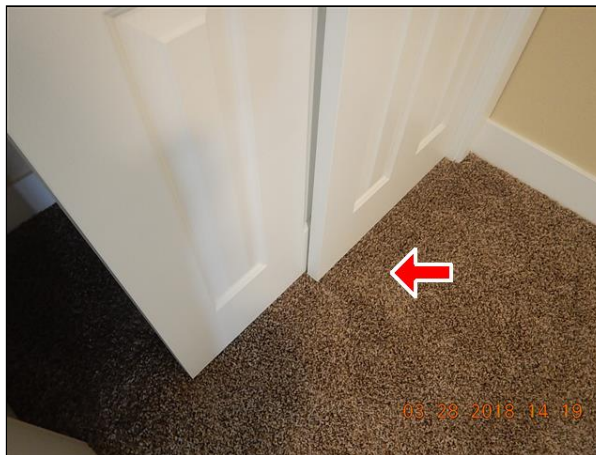
I recommend installing a floor guide for the bottom of sliding closet doors not having one. This is meant to keep them in place and from accidentally falling off of the track and rubbing against each other damaging the door finish. Noted: multiple bedroom closet doors

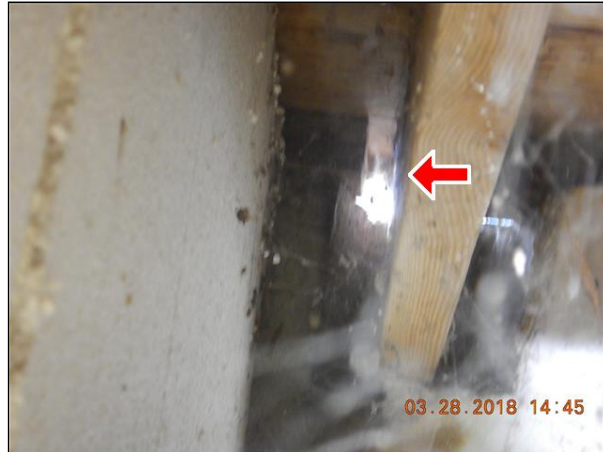
(3) There are some visible gaps into the crawlspace at the chimney area that can be sealed / foamed to prevent pest entry.

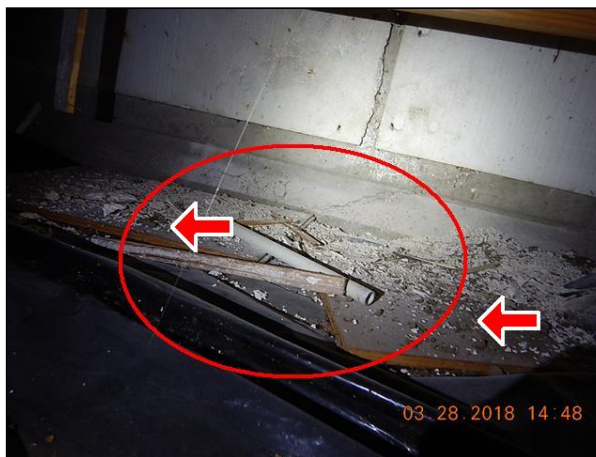
(4) The construction debris, insulation laying on ground, etc needs removing from the crawlspace under home. This could contribute to potential pest intrusion.

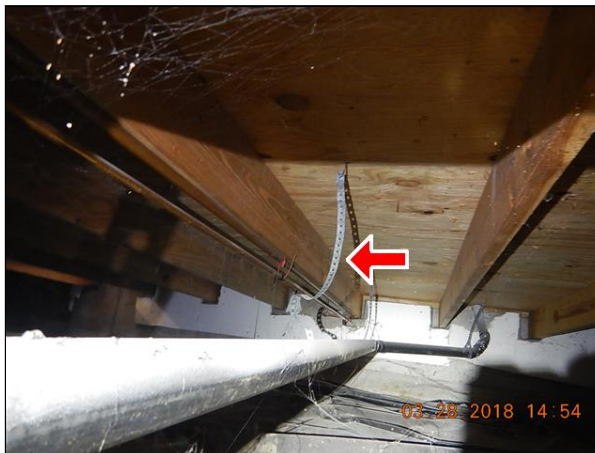
🔧 (1) There are some straps missing / loose on the drain waste vent piping in the crawlspace. Recommend repair as necessary so the piping is supported every 4 feet as required.

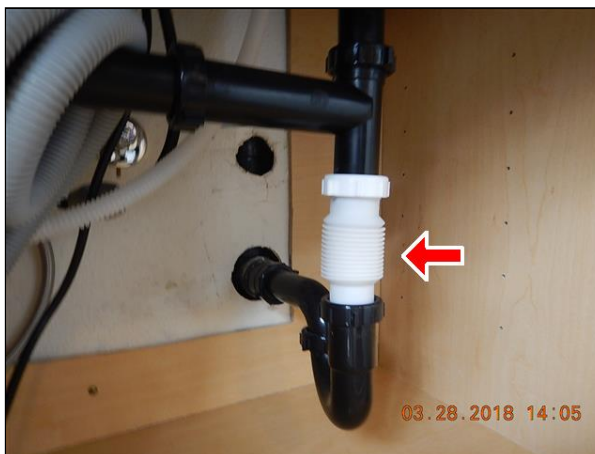
🔧 (2) There is non-professional plumbing under one or more sinks. Corrugated pipe is not acceptable for plumbing drain pipes. Plumbing drain pipes should be made of approved material and be smooth walled for proper drainage of water and to prevent blockage. Recommend repair with a proper plumbing drain pipe by a qualified person or a plumber. Areas noted: Kitchen sink under counter

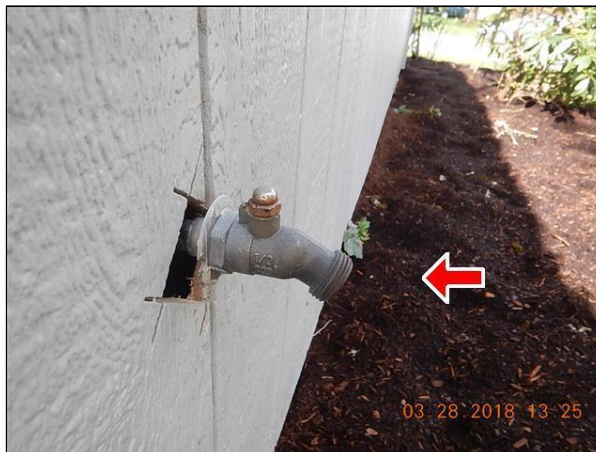
(2) The front of home hose bib does not have a handle. Repair as necessary.

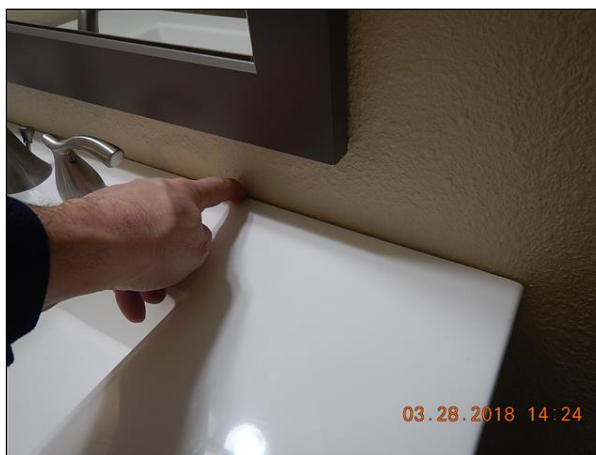
(4) Add sealant / caulk to the wall / sink backsplash area to prevent water running behind the sinks (2 bathrooms).

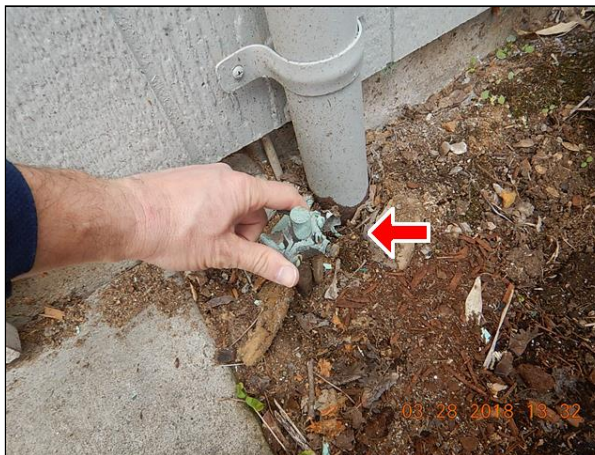
⚠ (5) The ground clamp is loose at the ground rod. This does not provide a good ground for the electrical system, and is a potential safety hazard. I recommend repair so the clamp is tight for a good ground for the electrical system.

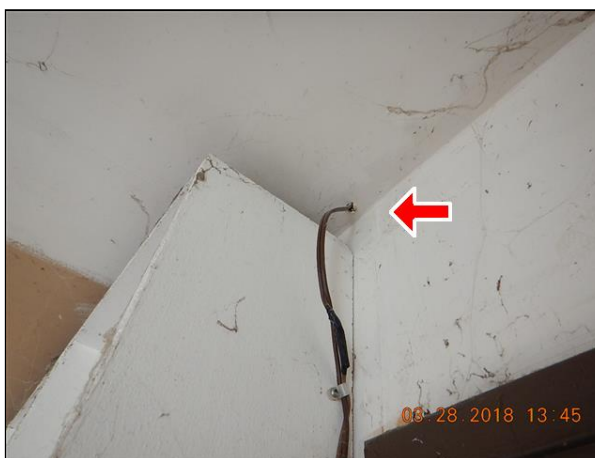
⚠ (1) There are one or more extension cords used as permanent wiring. Extension cords should not be used as permanent wiring and should never be ran through walls, ceilings, floors, etc. This is a potential fire hazard. Recommend installation of electrical outlets by a licensed electricians where permanent wiring is needed and removal of any extension cords used as permanent wiring. Areas noted: garage has extension cord going into attic

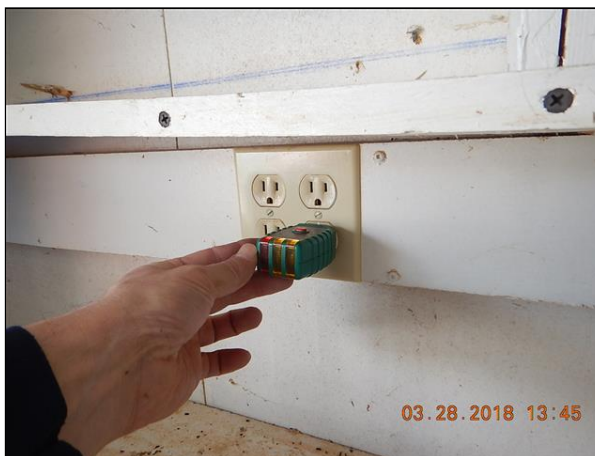
🔌 (2) One or more electrical outlets around the home did not have voltage at the outlet. Recommend repair by a licensed electrician. Areas noted: garage North / outside wall (multiple)

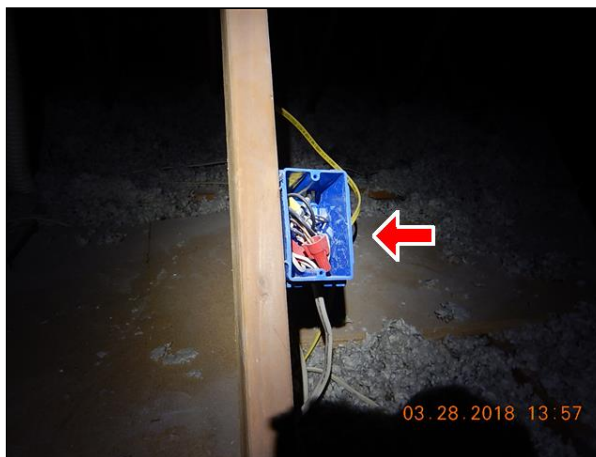
⚠ (3) There is an open junction box in one or more places. Junction boxes should have a cover and have no exposed wiring. This is a potential safety hazard. Recommend a licensed electrician repair as necessary. Areas noted: attic

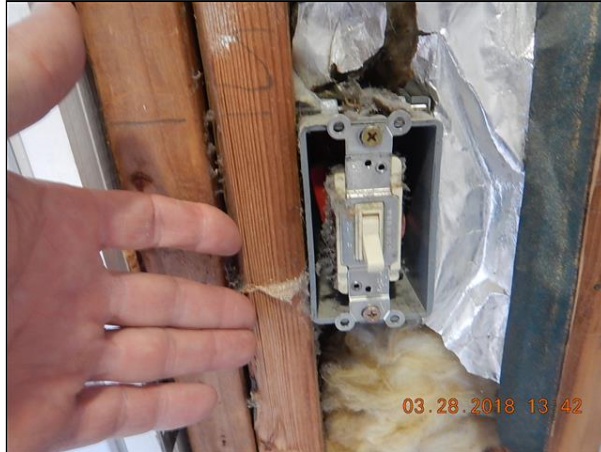
⚠ (2) One or more electrical switches or electrical outlets in the home do not have covers installed. This is a potential safety hazard. Recommend installing covers in these areas. Noted: garage

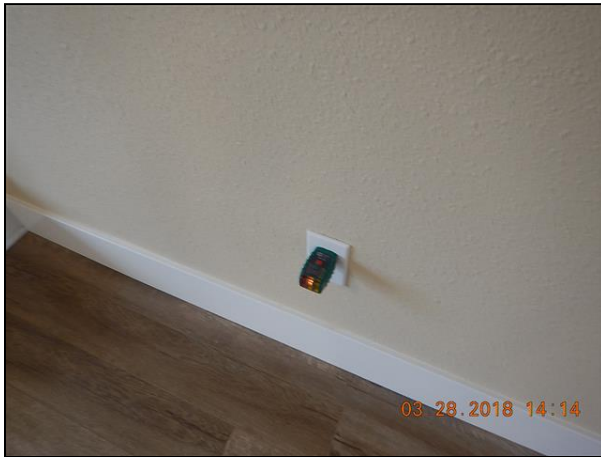
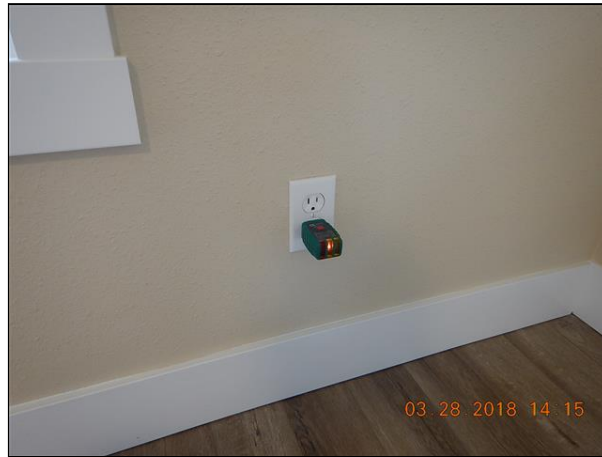
+ There is an open ground at one or more electrical outlets in / around the home. This is a potential safety hazard. I recommend repair by a licensed electrician. Areas noted: living room (2 near fireplace)

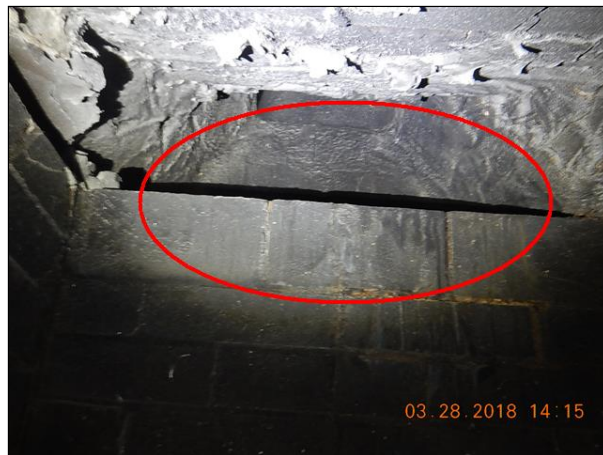
🔧 (2) The damper for the fireplace is missing. I recommend repair as necessary by qualified chimney sweep or contractor.

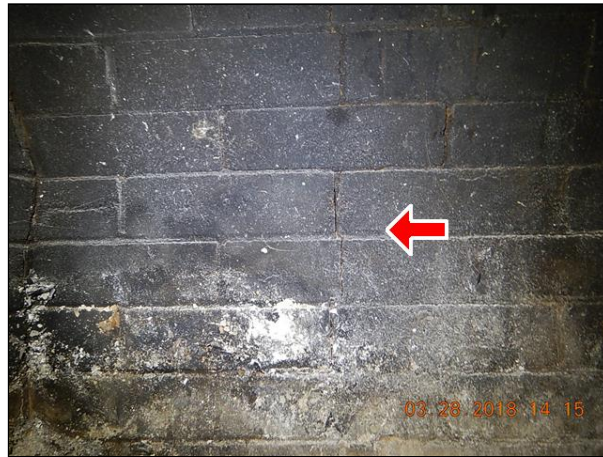
(1) The fire brick in the rear of the fireplace has minor hairline cracking. Recommend if significant gapping develops (1/8 inch or larger), review by chimney sweep for repair as necessary.

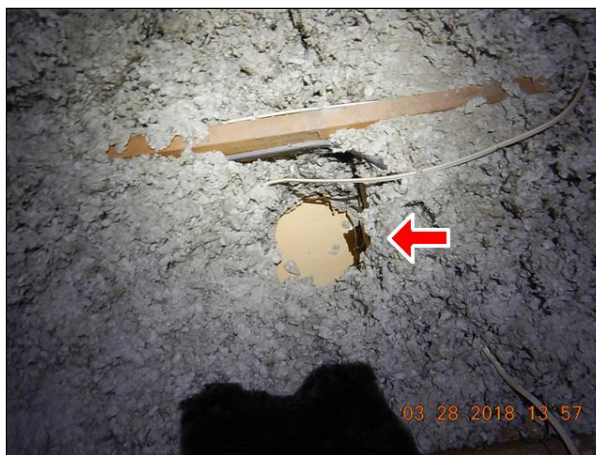
🔧 (1) The insulation is compressed in some areas of the attic due to foot traffic and some small areas have no insulation. This can result in loss of efficiency in these areas. I recommend redistributing some insulation or adding additional in these areas as necessary.

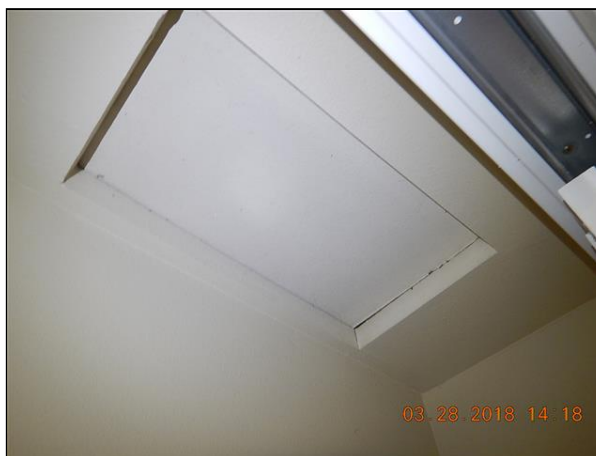
(3) There is no insulation installed on the attic hatch. This can result in some loss of energy efficiency. Recommend insulation be installed on the top of the attic hatch (the hatch in the bedroom closet)

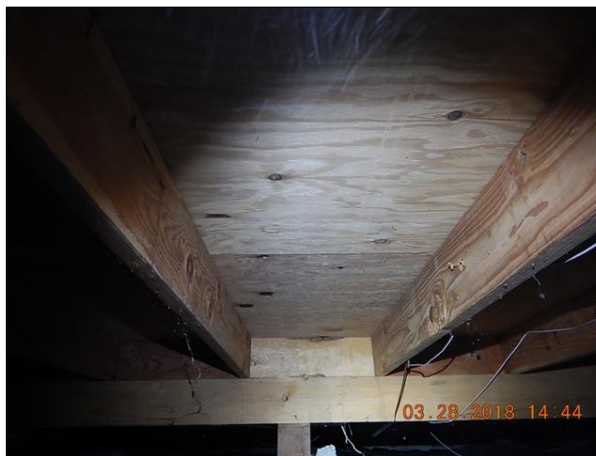
The house flooring does not have insulation installed. I recommend installing insulation under the floor in the crawlspace for additional energy efficiency in the future. The recommended R value of insulation in crawlspaces for our area is currently R30.

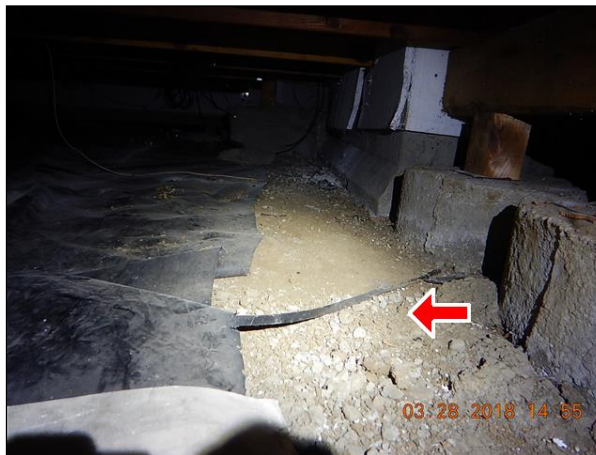
Some areas do not have a plastic vapor barrier or have areas which are not covered with vapor barrier. I recommend install / adjust to cover these areas in the crawlspace to help with moisture control in the crawlspace. Noted: by crawlspace hatch, and under fireplace

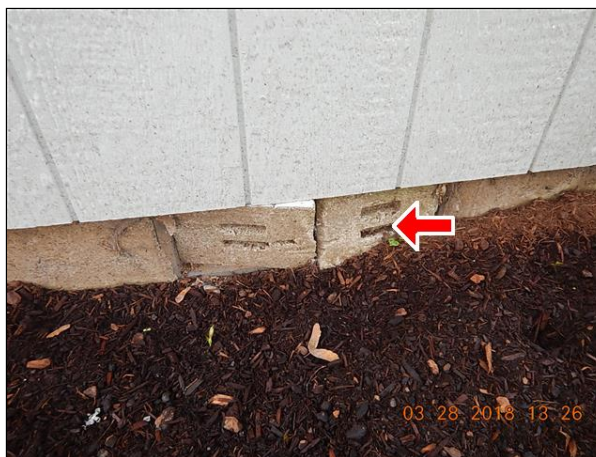
(1) There were one or more crawlspace vents blocked or partially blocked with styrofoam blocks or other material. Recommend removing blocks / material / debris to ensure adequate airflow and ventilation in the crawlspace. Recommend keeping vents clear of debris. Many people choose to block the vents in winter time. This is an acceptable practice, however, at a minimum, I recommend having them open in warmer weather for ventilation / moisture control.

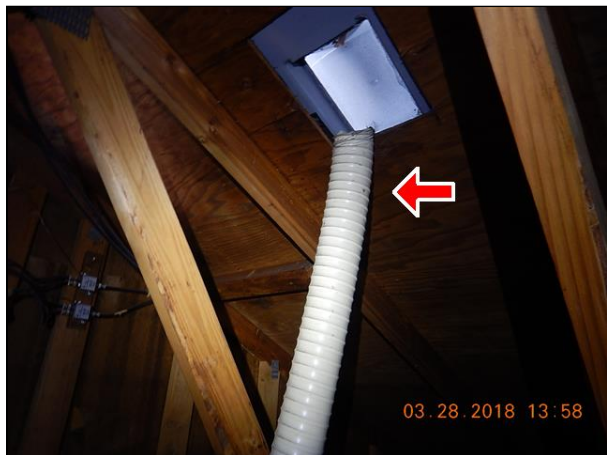
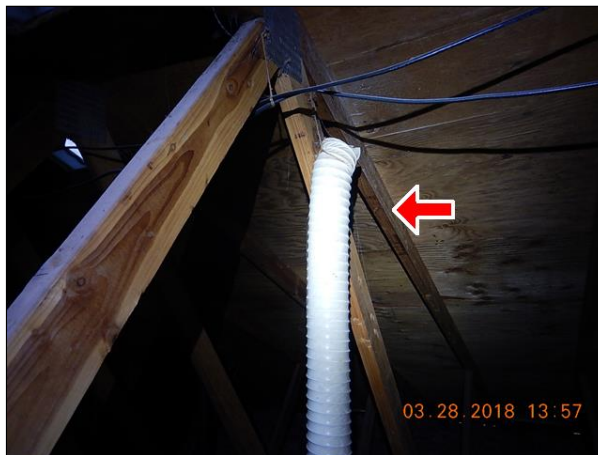
(2) There are multiple exhaust vent(s) in the attic that terminate directly into the attic rather than completely to the home's exterior. This is improper by current standards and could lead to moisture related issues including mold growth. I recommend repair so that all bathroom, kitchen and laundry exhaust air is vented completely to the home's exterior, and are not using openings designed for roof / attic ventilation.

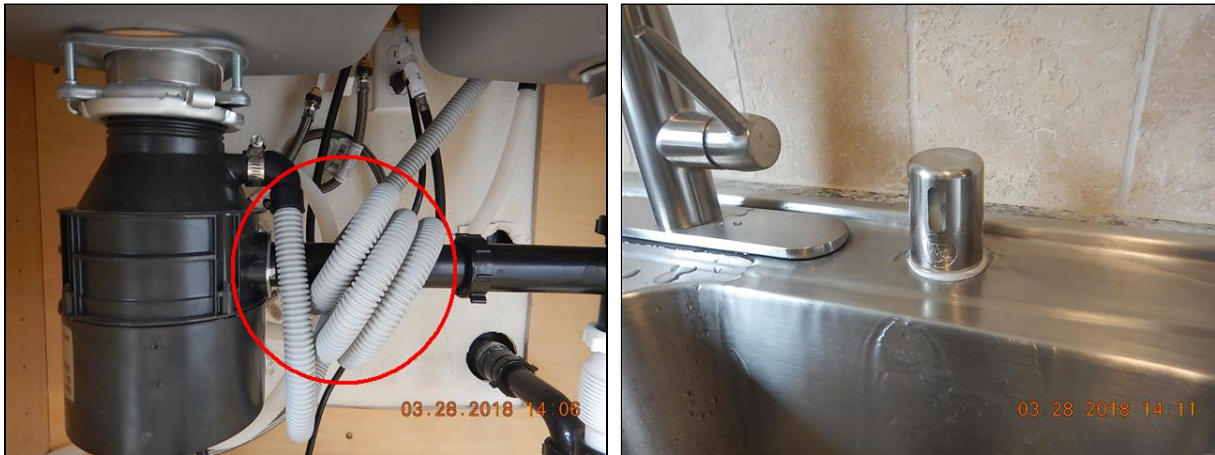
🔧 The air gap on the counter top leaks water when the dishwasher is draining. This indicates a partially clogged drain line or an issue with the air gap installation. Recommend repair as necessary. Note: there is excess drain line wrapped around the drain under the sink that can be eliminated and potentially fix this issue

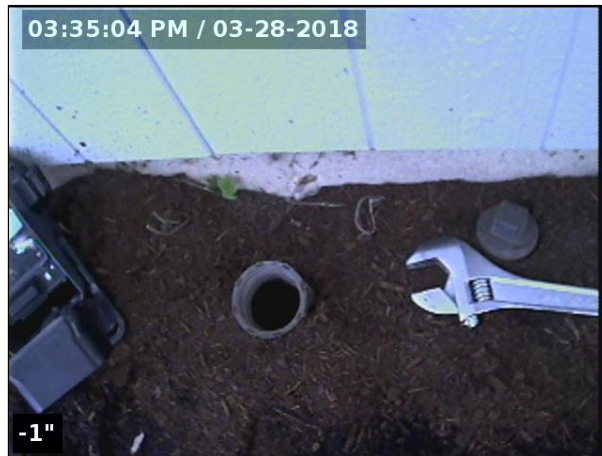
*Items***12.0 Cleanout located Inspected: Satisfactory**

There was a cleanout or entry point located for inspection the sewer line. Cleanout or entry point location: Side of home at cleanout (right side facing front)

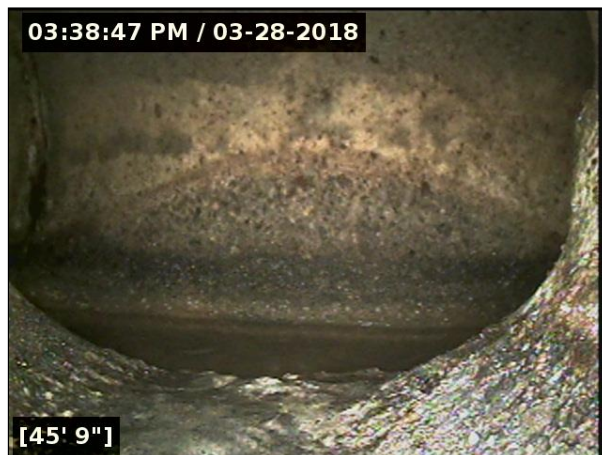
**12.1 Length of sewer line Inspected: Satisfactory**

The overall length of the sewer line from the entry point to the sewer main is approximately: 46 feet
